LEAKY BANJO FITTINGS: Banjo fittings require two sealing washers. The copper washers used to seal the banjo fittings at the back end of the tappet blocks are really thin, only about .010" thick. This is too thin for reliable sealing, so chances are pretty good that these banjo fittings will leak right after assembly.

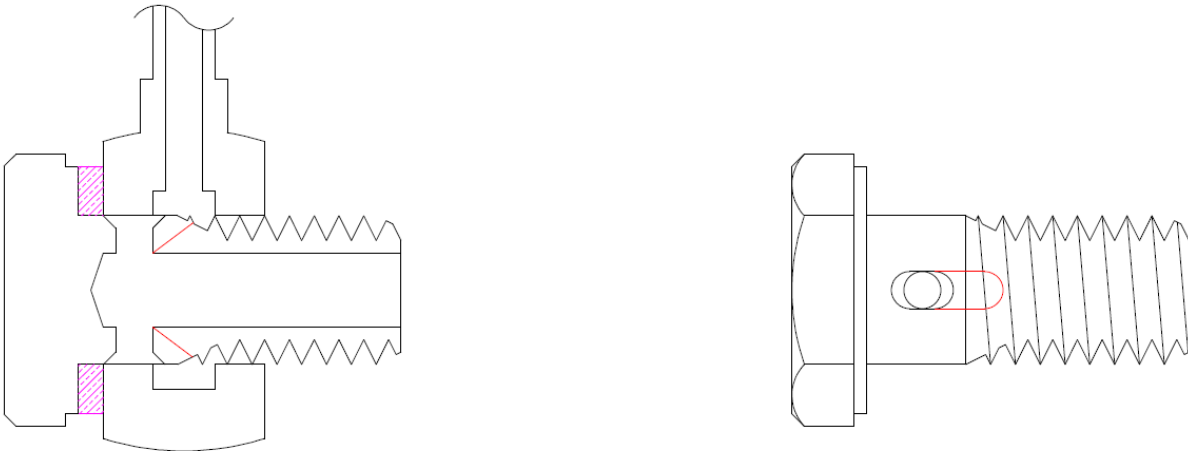
Craig Sawyers pointed out that the alignment of the cross hole in the banjo bolt doesn't line up with the channel inside the collar as well as might be hoped -- see Figure 1. The collar is about 13/32" thick, with the channel right in the middle, but the cross hole in the bolt is located only about 5/32" from the underside of the head -- and the thickness of the sealing washer between the bolt head and the collar makes this misalignment even worse. The drawing at left includes a 1/16" thick copper washer, and the two passages barely overlap. Jaguar's fix: those really thin sealing washers described above.

Figure 1: Banjo Bolt Modification for Better Flow

A better fix is pretty easy, though: using a Dremel or some such, lengthen the opening on the cross hole in the bolt in the direction of the threaded end (basically, enlarge the chamfering in that direction). This will help the oil flow to the camshafts even if the original thickness washers are used. Ideally you will want to extend the edge of the cross hole to about 5/16" or 8mm from the underside of the bolt head.
