This REOPUS 3/4 Amplifier has been modified operate with a REOPUS H PICKUP.

This REOPUS 3/4 circuit board has been factory modified to operate with the REOPUS H pickup.

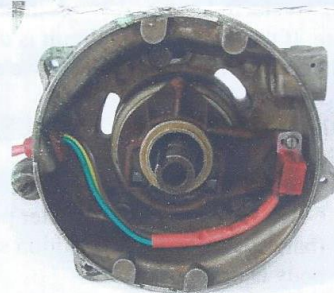
Install the REOPUS H pickup.

Make sure the pickup wiring is clear of the Timing disc.

Refit the timing disc and set the pickup gap to between 0.020 and 0.025in.

Check Pickup clearance to rotor. I have found 0.020 to be the best starting point. There is more information on www.reopusignition.com about adjusting pickup gap and Ignition duty cycle.
